**SERVICE HINTS**

RCA Models: 4X, 4X3, 4X4

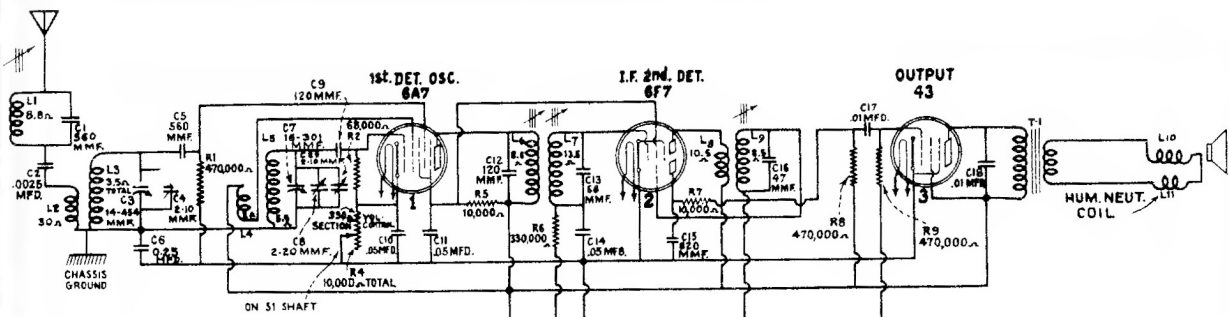
*Schematic Circuit Diagram*

- (1) Excessive hum or distortion is sometimes caused by pilot lamp socket short-circuiting to chassis.
