GENERAL ELECTRIC
MODEL 741
RADIO-PHONOGRAPH

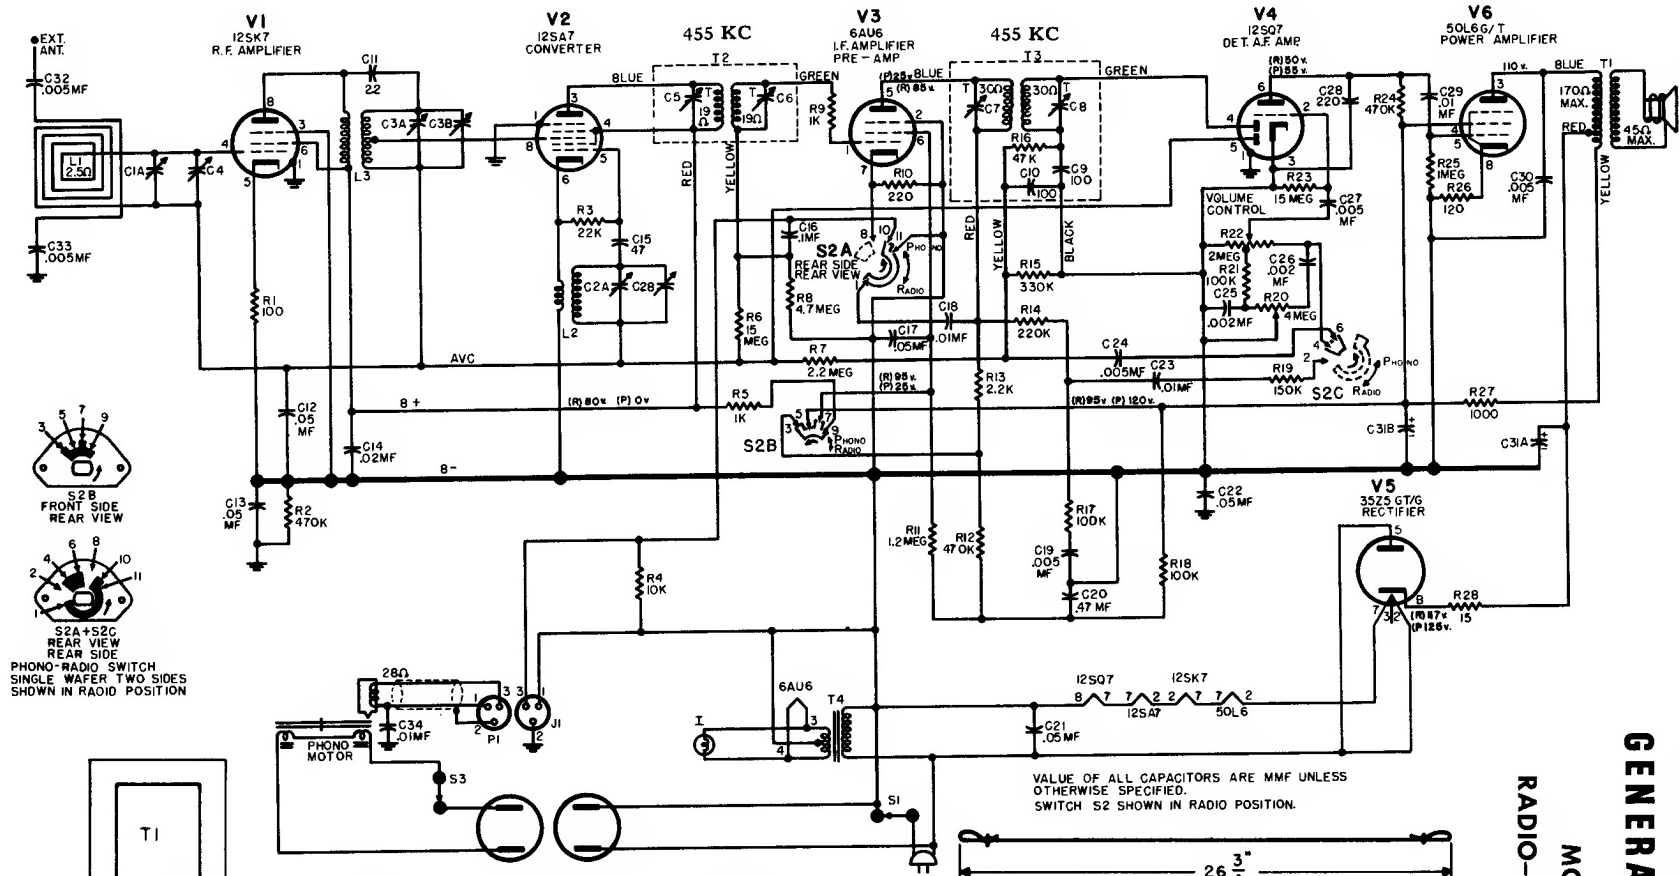
VALUE OF ALL CAPACITORS ARE MMF UNLESS OTHERWISE SPECIFIED.
SWITCH S2 SHOWN IN RADIO POSITION.

A gassy 12SA7 or 12SK7 may cause poor A.V.C. action thereby overloading the R.F. circuits and causing audio distortion at any setting of the volume control.
