**Schematic Diagram, Chassis 8HF2**

# Packard Bell

Model RC-1S, Chassis 8HF1 or 8HF2

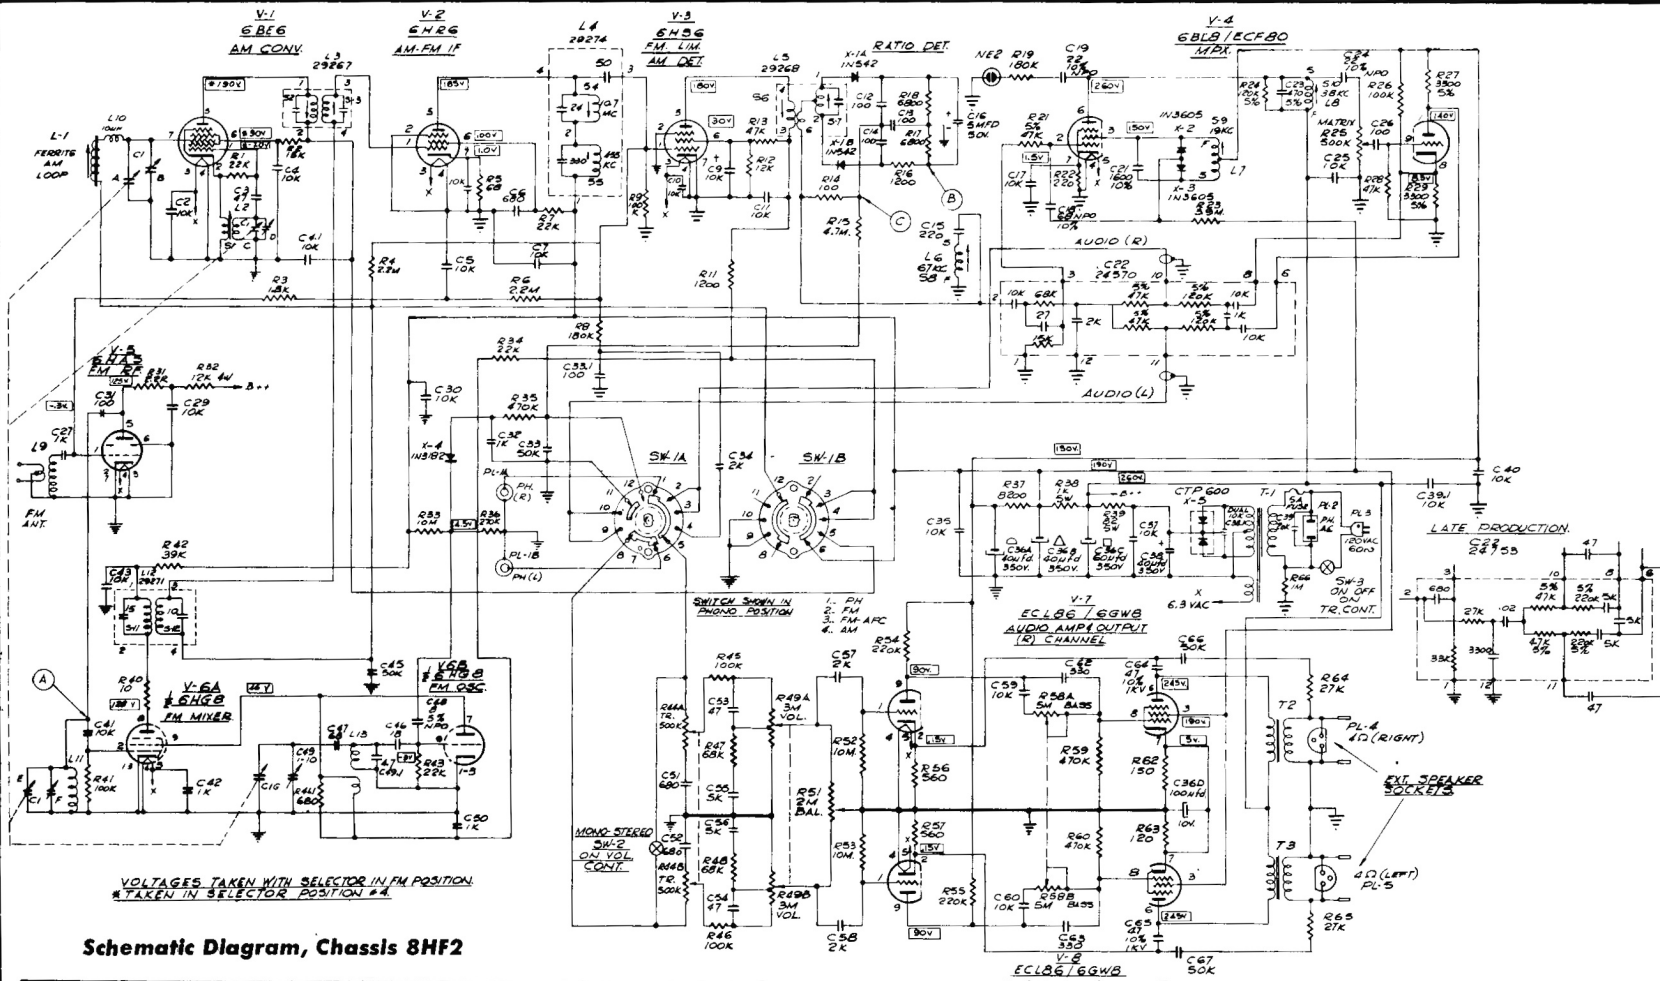
**Intermediate Frequencies:**  
 AM Radio: 455 kc  
 FM Radio: 10.7 mc

**Model RC-1S** contains either chassis **8HF1** or chassis **8HF2**. These chassis are similar, each being an AM/FM radio receiver with built-in multiplex circuitry.

The major difference between the 8HF1 and 8HF2 is that the tube types of V-5 and V-6 differ, along with the associated circuitry.
